3 Assessment and Characterization of Damages

3.1 Wind Effects

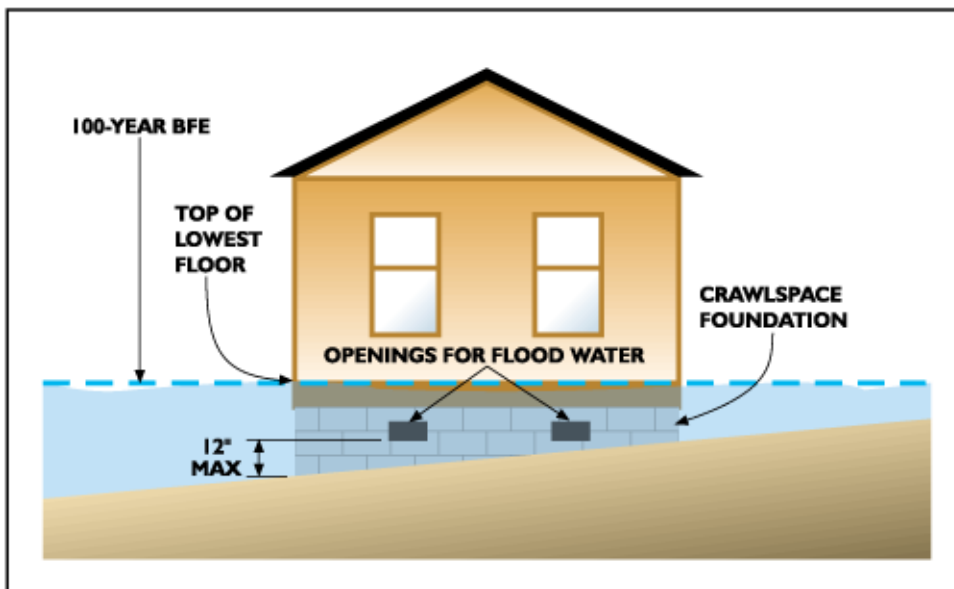
FIGURE 3-10 The top of the lowest floors of buildings in A-Zones must be at or above the BFE. Foundation walls below the BFE must be equipped with openings that allow the entry of flood waters so that interior and exterior hydrostatic pressures can equalize.

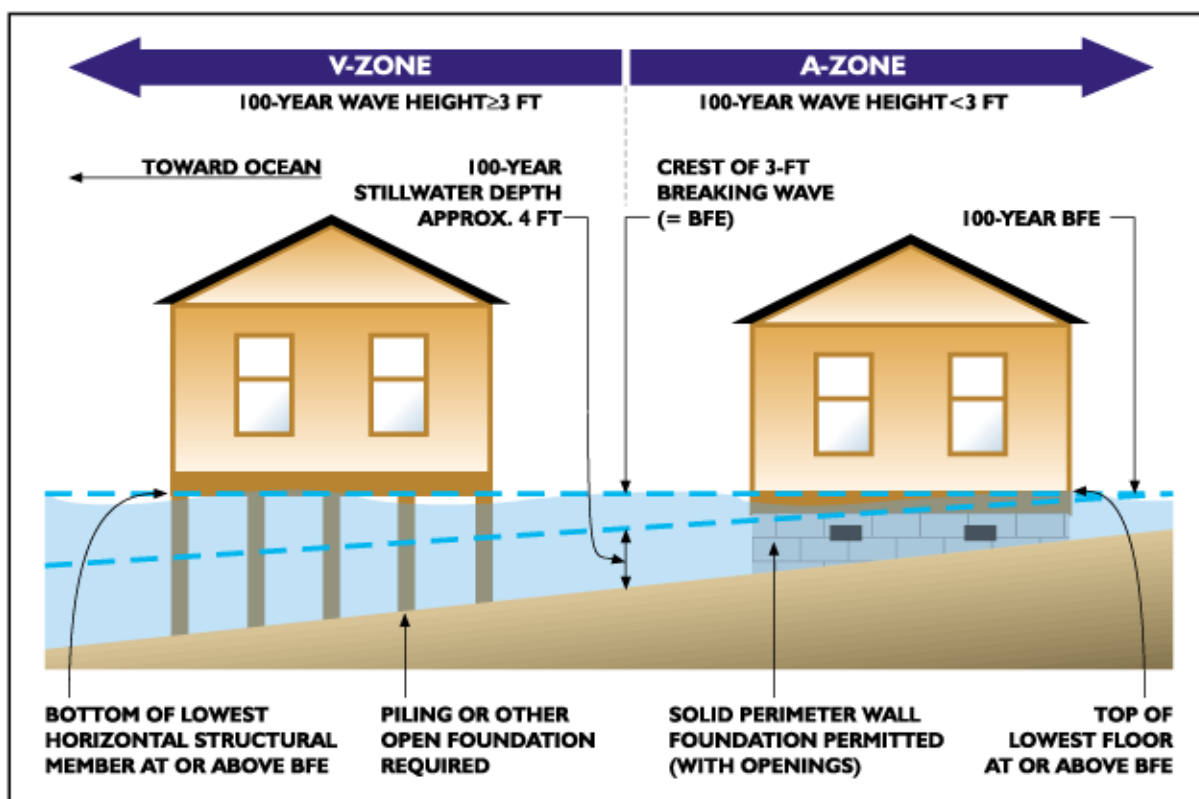
FIGURE 3-11 Comparison of building foundation and elevation requirements in V-Zones and A-Zones.
